**Flood Control Project Maintenance
Levee Inspections**

Fall 2008 Levee Maintenance Deficiency Summary Report

Maintenance Area 0004

Levee Inspection Report By Mile - Fall 2008

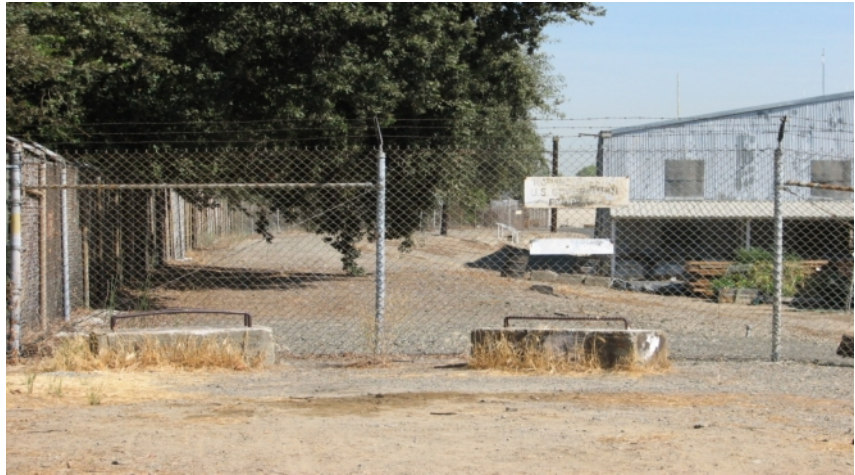
Levee Mile Report Line	2
Start Levee Mile	0.26
End Levee Mile	0.71
Location	
Category	Earthen Levee
Item	Encroachments
Corp. of Engineers fence across levee blocking levee crown

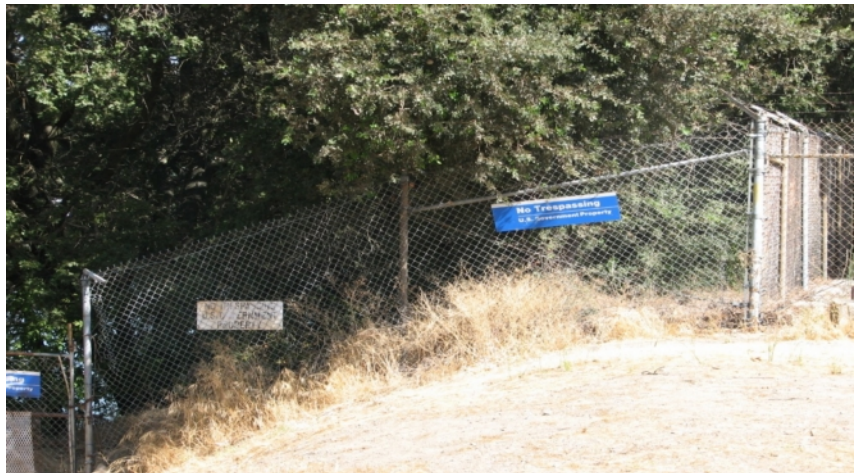
Levee Mile Report Line	2
Start Levee Mile	0.26
End Levee Mile	0.71
Location	
Category	Earthen Levee
Item	Encroachments
Corp of Engineers fence down waterside slope small walk thru gate at toe un able to inspect
